We received the following questions in regards to RFQ 2024-048.

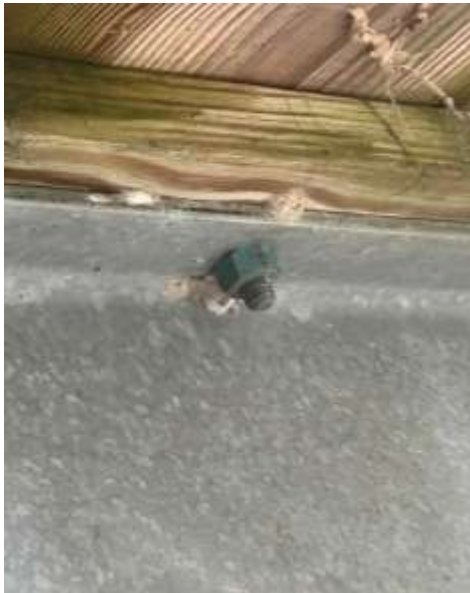
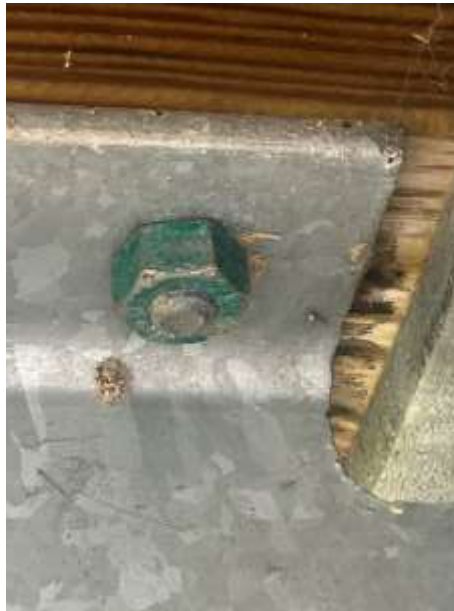
Answer: That plate is secured from the top down using galvanized bolts and nuts that are counter sunk. We did observe some of these fasteners and they appear to be in good shape and don't appear to have any issues that would cause removal to be a challenge. However, not each fastener was observed. Potential challenges should be factored into the quote. Please see attached photos...
